Report to the Common Council Regarding 106-108 and 118 Newfield Street

Summary

Landslide

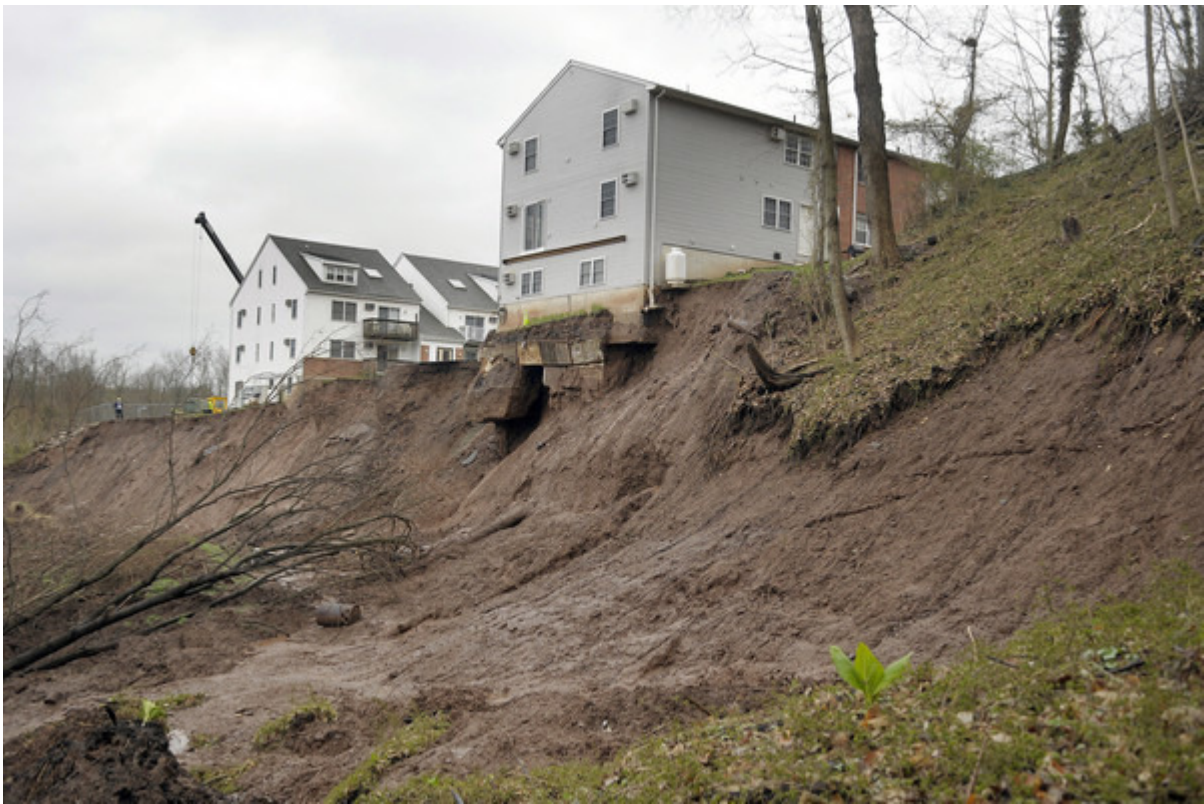
Hartford Courant- 2010

On March 30, 2010 at 3:30pm the Middletown Dispatch center received a phone call reporting a landslide had taken place near two apartment buildings at 106-108 Newfield Street and 118 Newfield Street. The two buildings with 44 units were evacuated due to the fact that the eastern section of 118 Newfield Street had its foundation expose. 106-108 Newfield Street did not have its foundation exposed, but a thin strip of earth was all that separated the building from the drop off caused by the landslide.

The landslide affected an area of one acre. The width of the affected area was 250 feet and traveled possibly as far as 200 feet. The landslide deposited a significant

amount of debris into the Coginchaug River. The result of which has dammed the river, raising the normal river depth by as much as four feet for a distance of 4,000 feet.

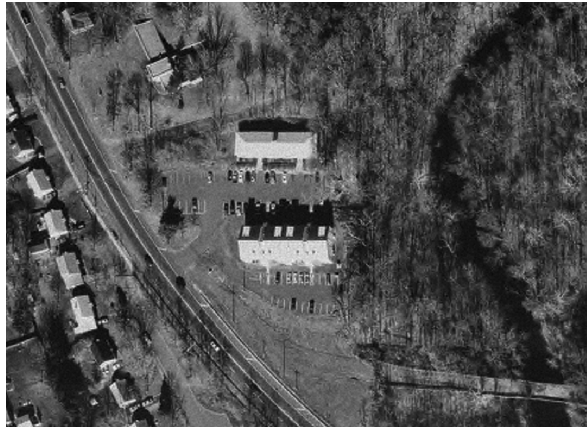
This approval was for the construction of a new 20 (one-bedroom) unit apartment building at 106-108 Newfield Street and was approved by the Planning and Zoning Commission. This Project placed a very significant amount of fill on the already steep natural slope. Based on site conditions after the landslide it was obvious this material was not properly placed.

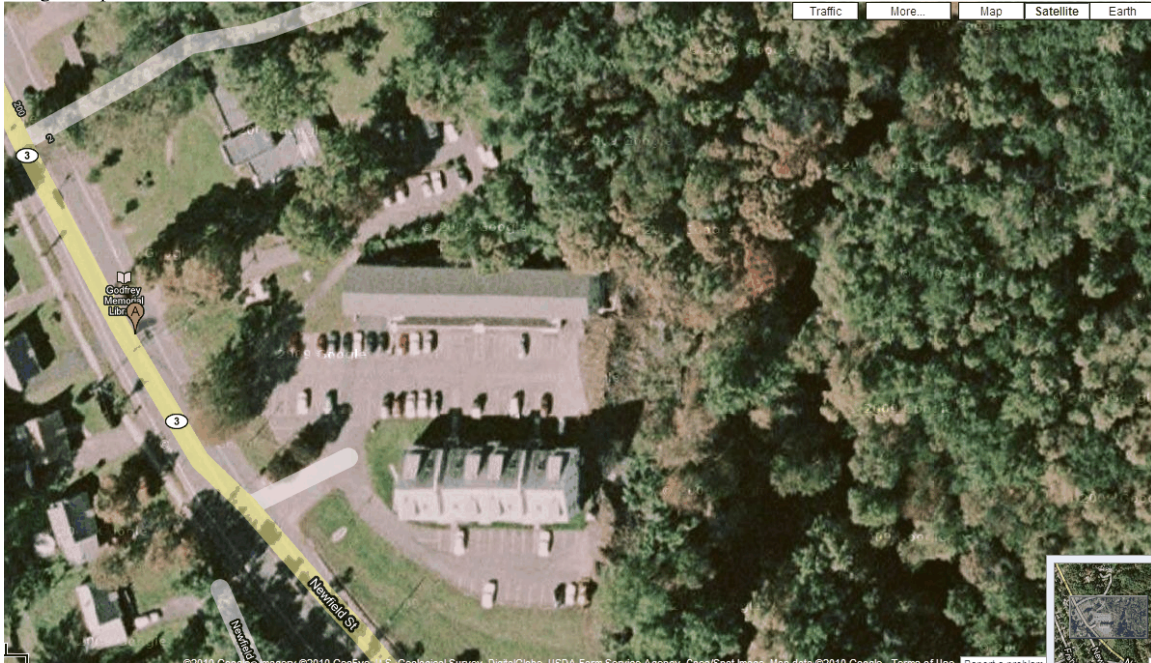
Google Maps- Aerial view – circa 2005 or 2006

A review of the available aerial photos, indicate that poor property maintenance was likely a contributing factor, essentially the placement of fill on an already very steep slope. Comparing the Google aerial photo from summer 2006, shows a vegetated slope. However the Bing Maps Birdseye view from spring 2007 shows a different story. There seems to be some indication that the property owner was placing additional fill on the already steep slope.

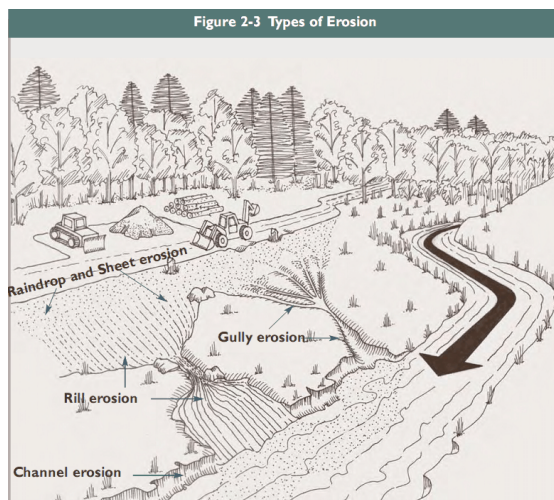
Records show that the City issued a notice of violation letter to Ted Charton on September 17, 2007 for filling and excavating and/or grading occurring within 100 feet of an upland review area. The filling activity at the site was likely not properly seeded or reinforced to prevent erosion.
